Evapco Engineering Flash

Passivation

**EEF #9
July 2015**

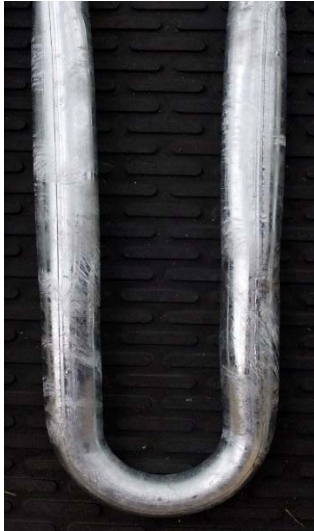
New galvanized coil

Routine visual and photographic inspection of the galvanized surfaces, to include panels as well as coils, should be incorporated into the passivation plan. Successful passivation will turn the bright new galvanized steel to a duller grey layer which indicates that the zinc has been passivated. This zinc/carbonate layer protects the zinc from premature corrosion known as white rust. Identifying white rust early in its formation can ultimately prevent serious damage from occurring.

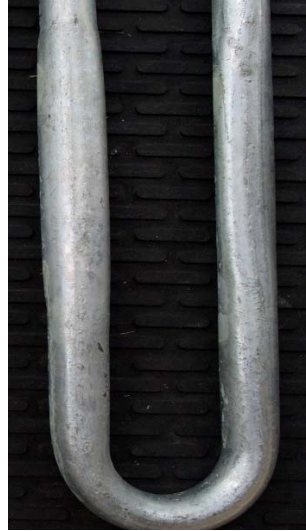
Passivated coil

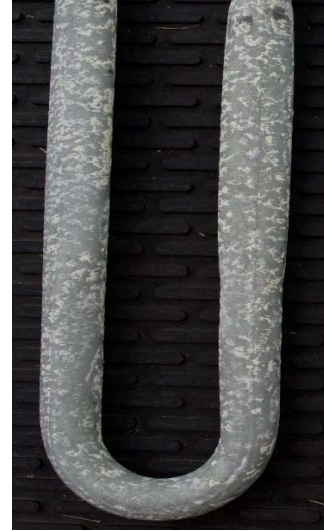
White rusted coil

White rust is localized, premature corrosion of the zinc that appears as white spots on the galvanized surface. The rapid corrosion can completely remove the zinc in small areas which can leave the underlying steel exposed thereby reducing the service life of the equipment.
